Safe Harbour Village Condominiums

SIRS

Re: Safe Harbour Village Condominiums
 Structural Integrity Reserve Study (SIRS)
 8253 Navarre Pkwy., Navarre, Florida
 UES Project No: 6011.2400258.0000

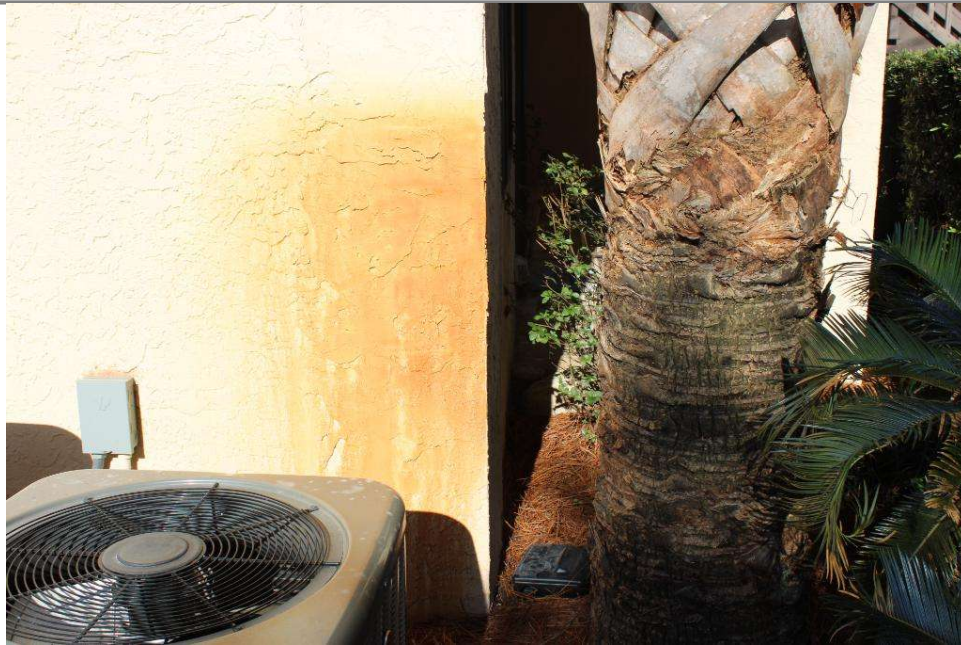
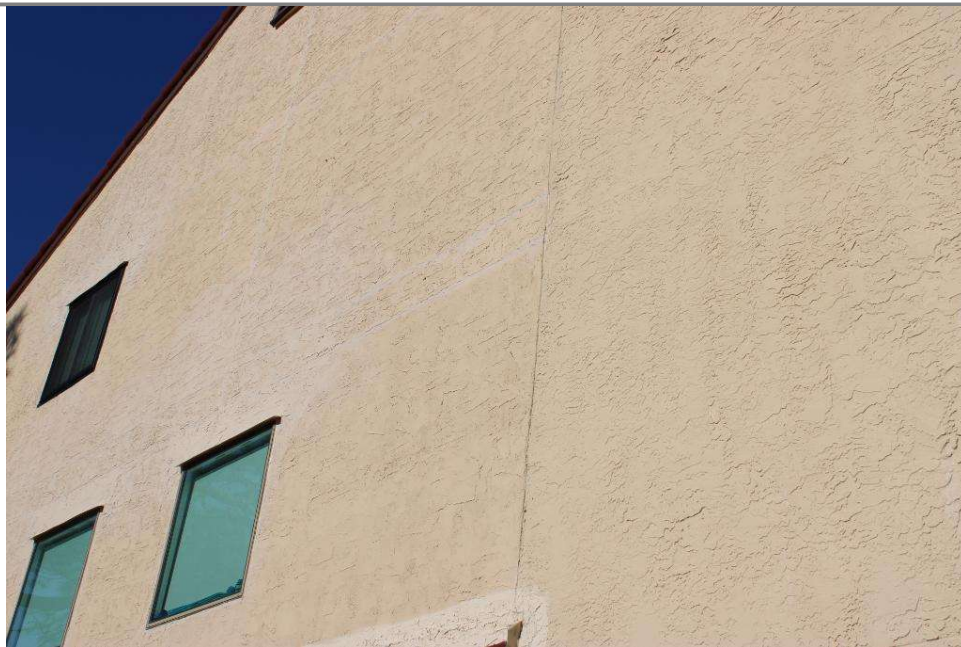
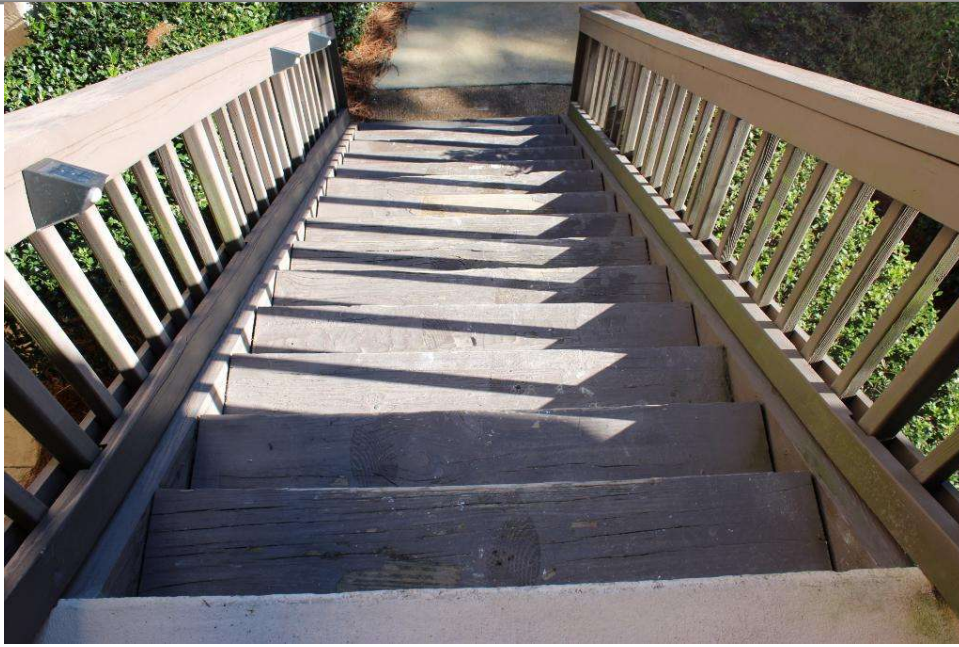
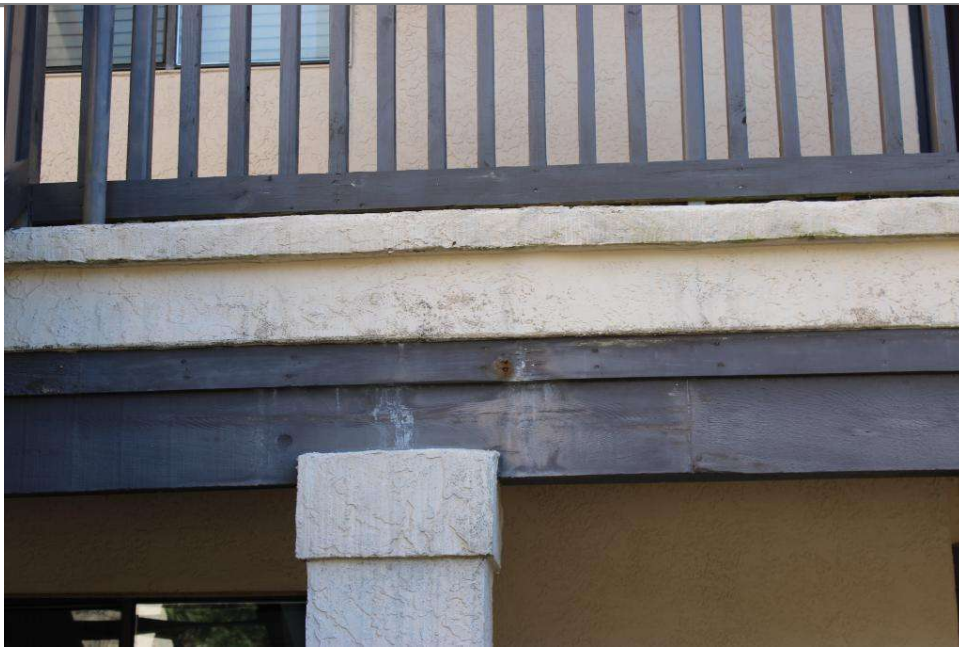
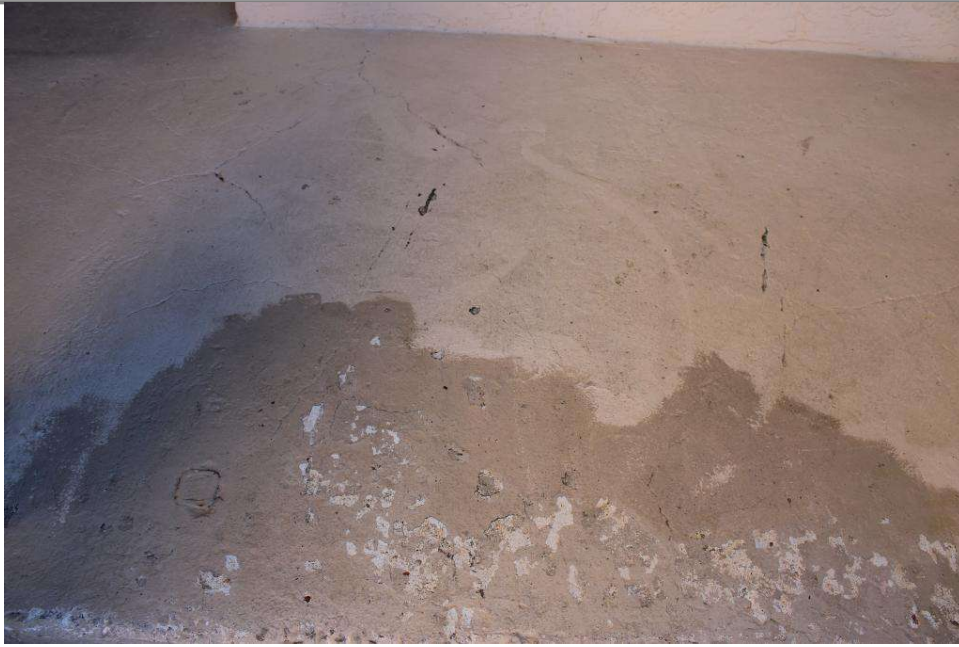
Exterior Building paint

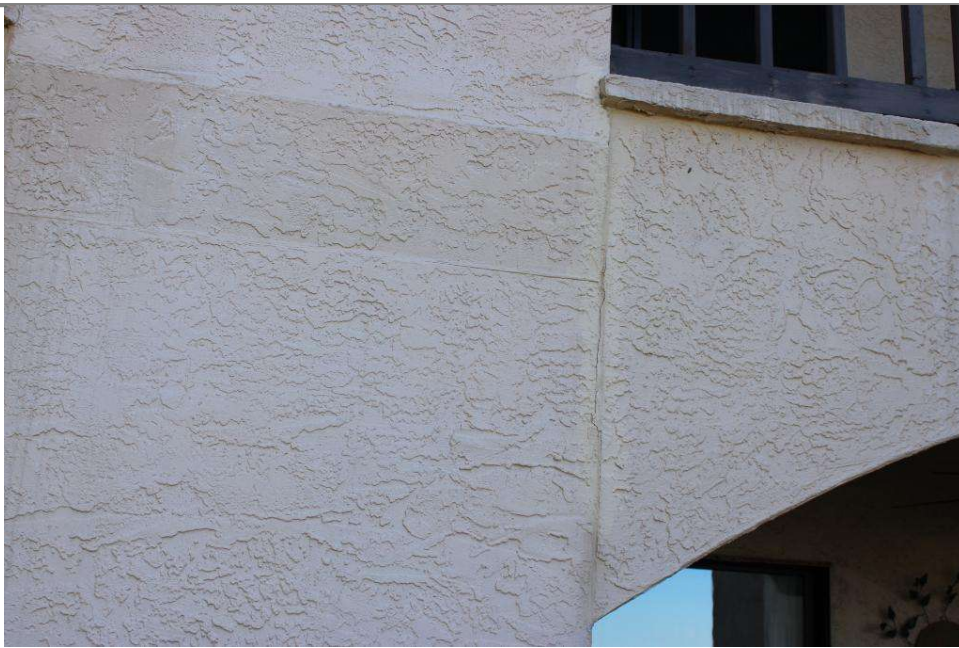
Building Sealant

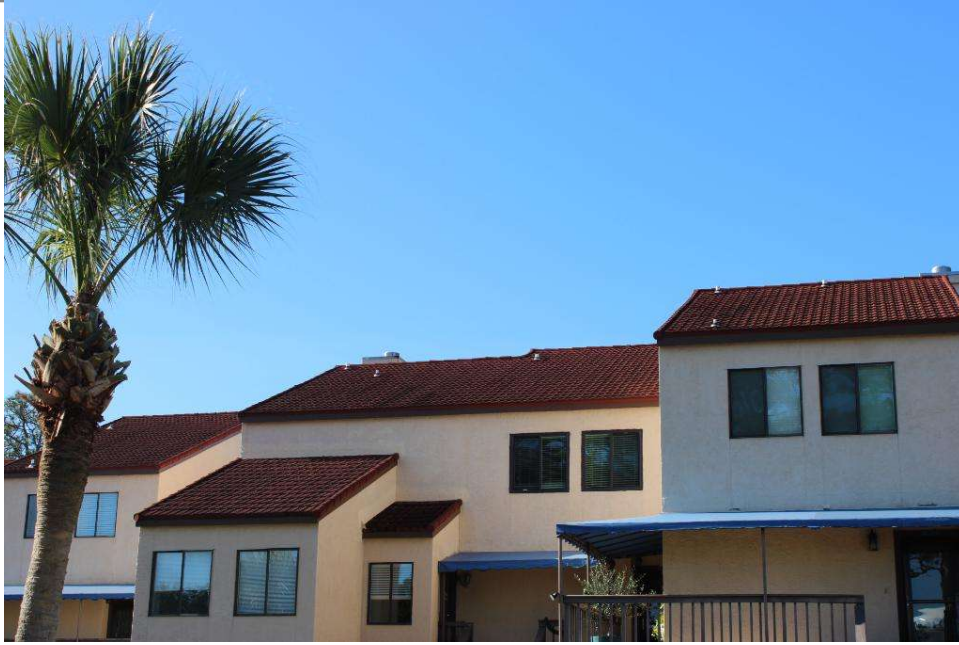
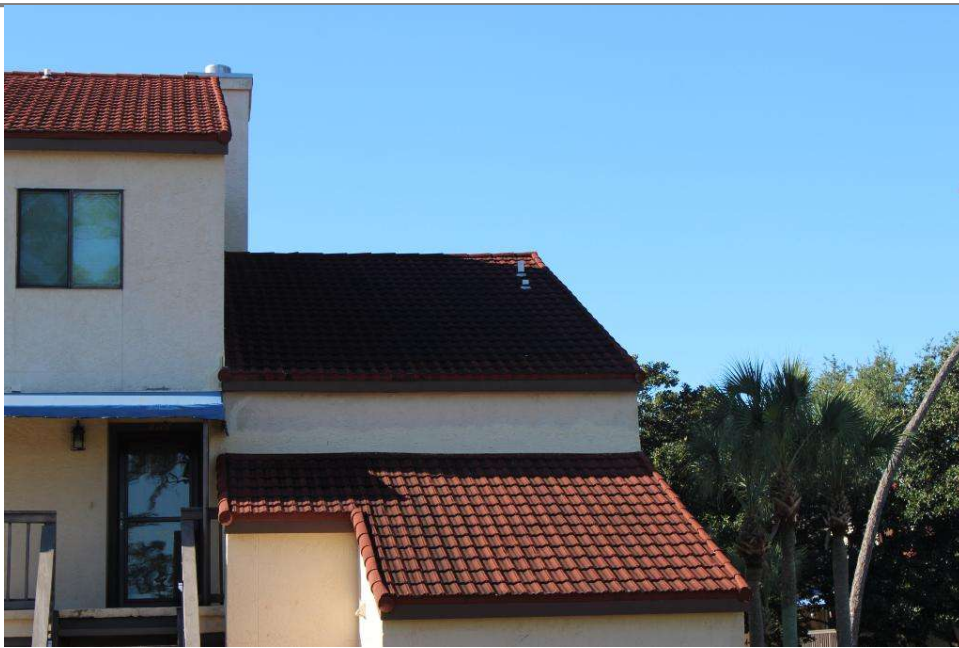
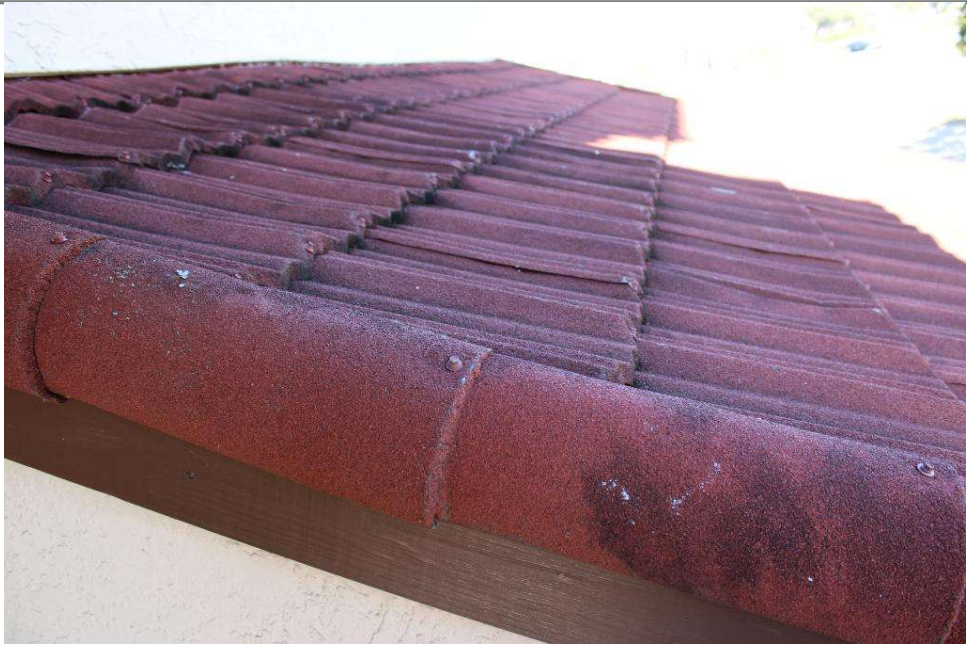
Roof

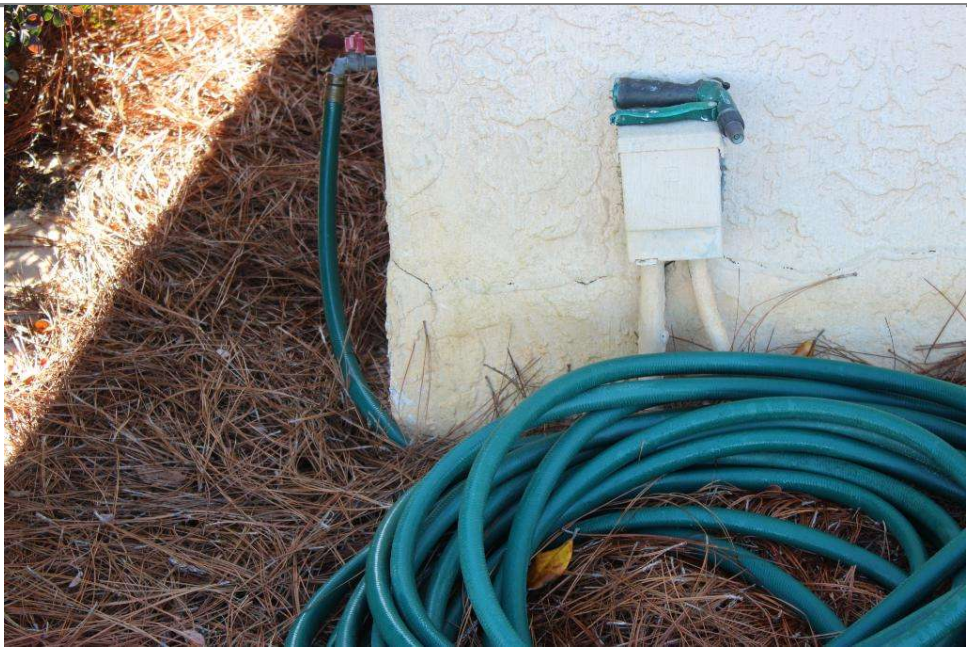
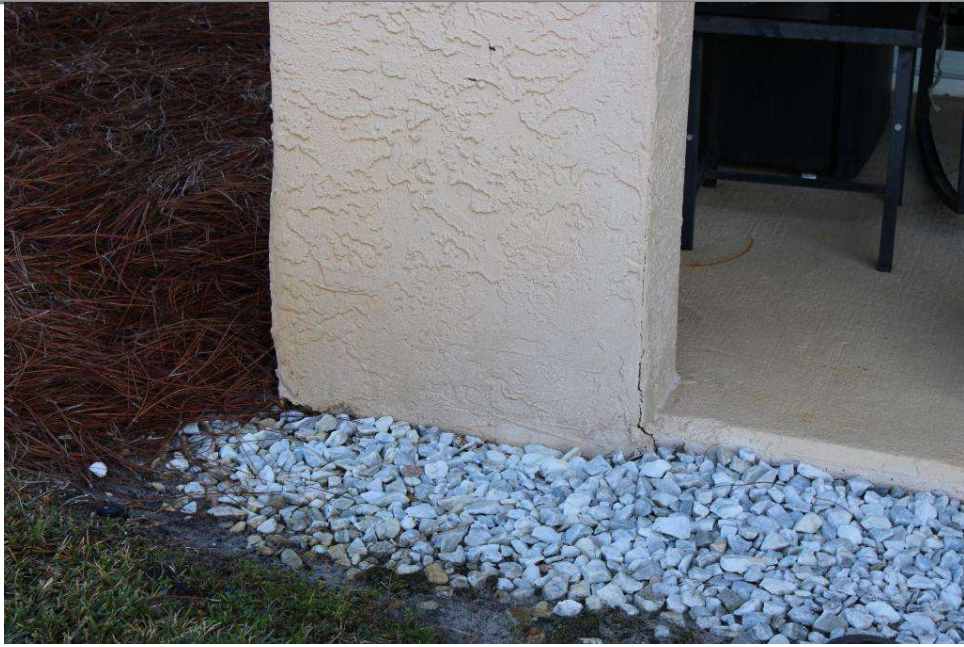
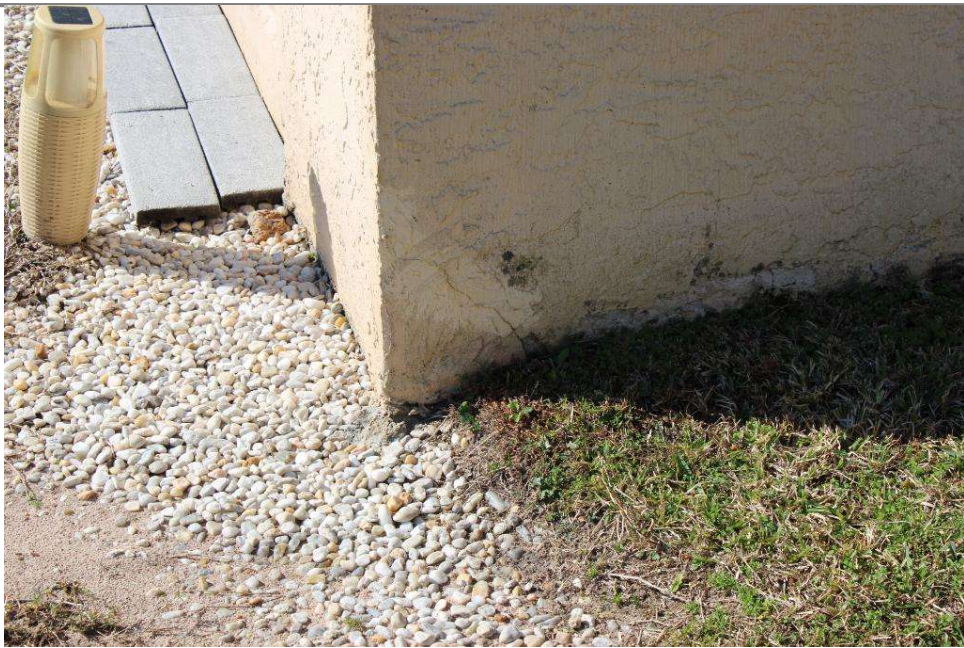
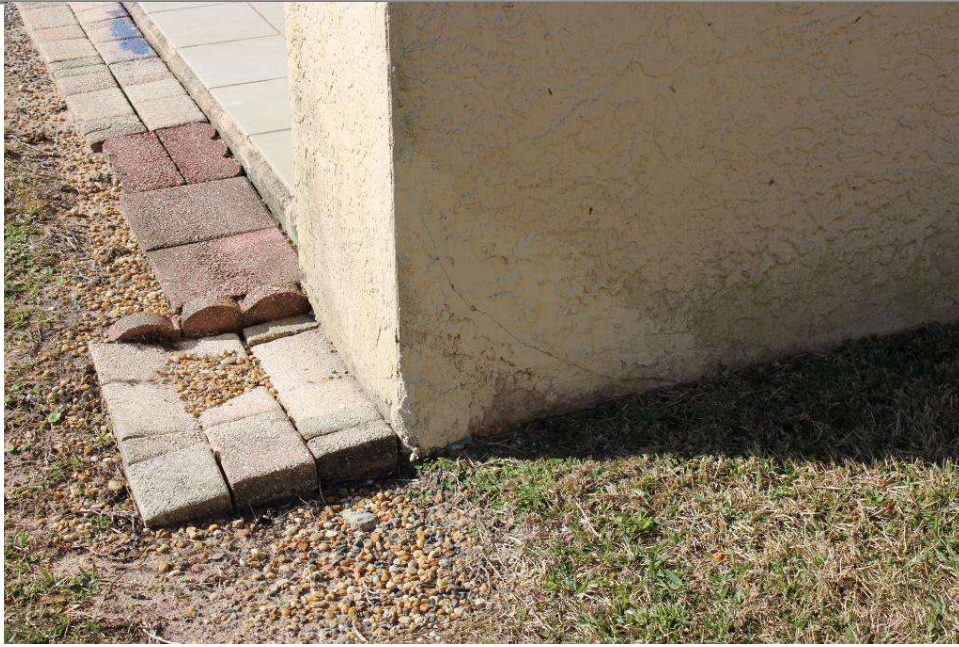
Stucco Repair

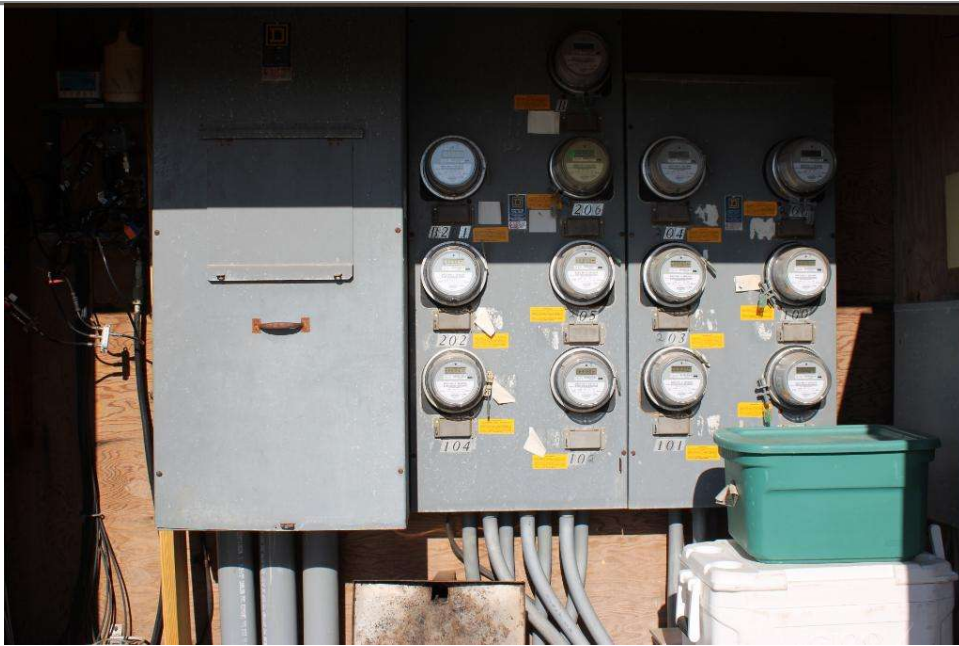
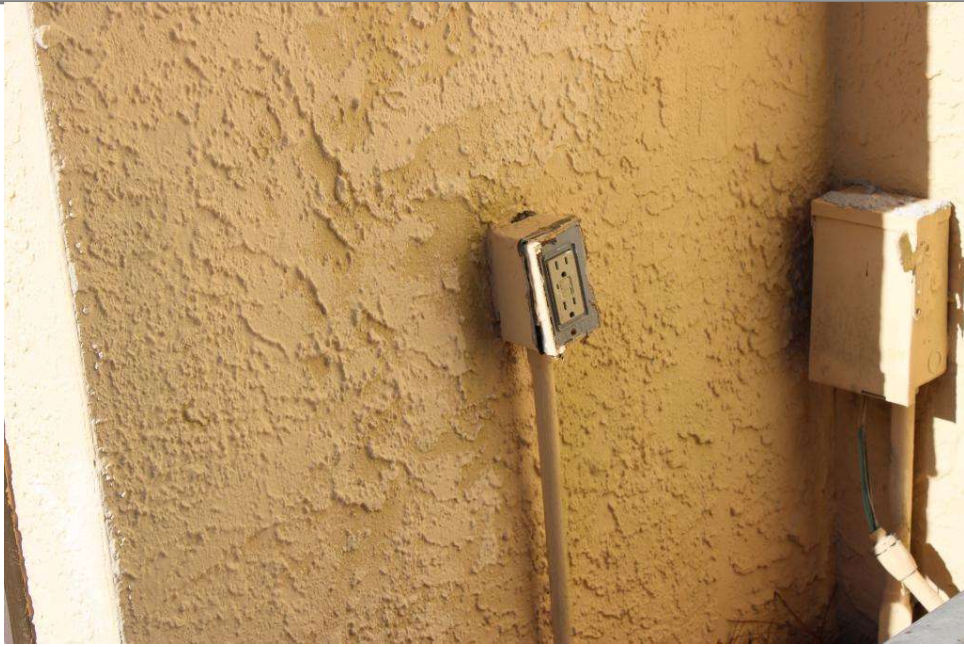
Electrical-Annual Routing Maintenance

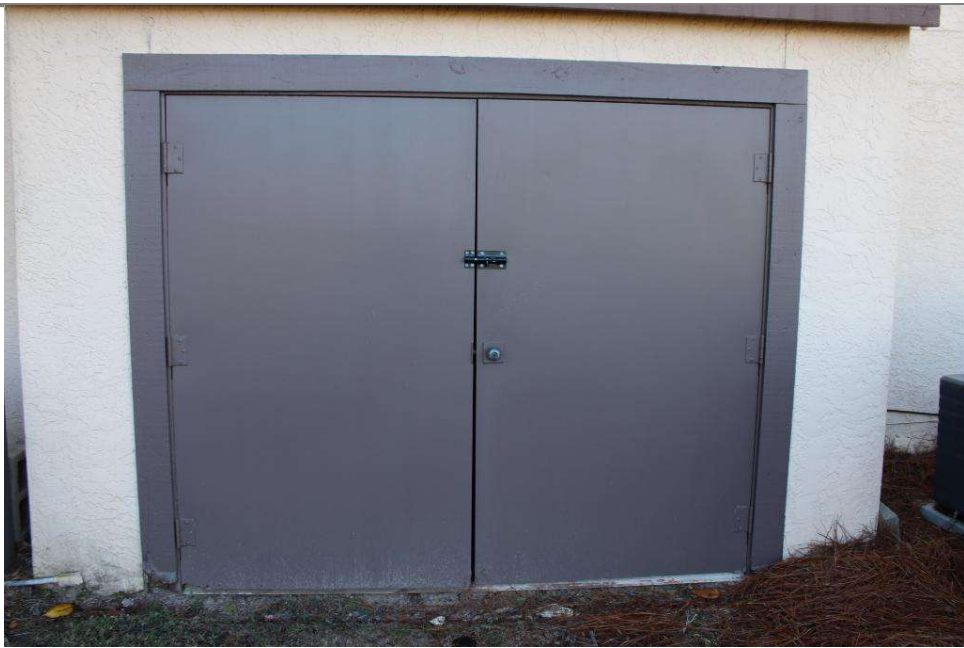
Doors

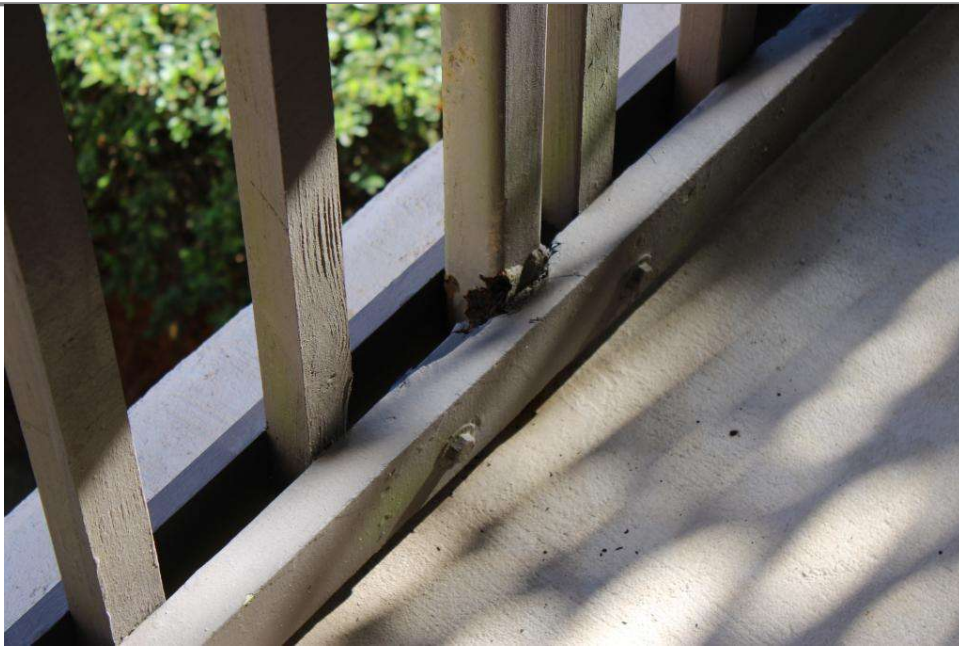
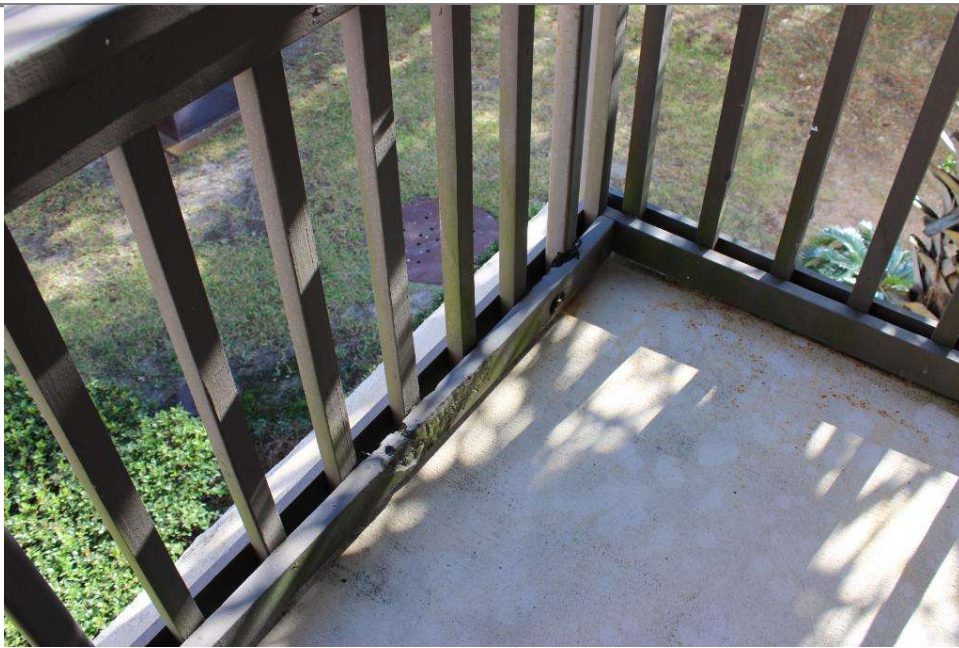
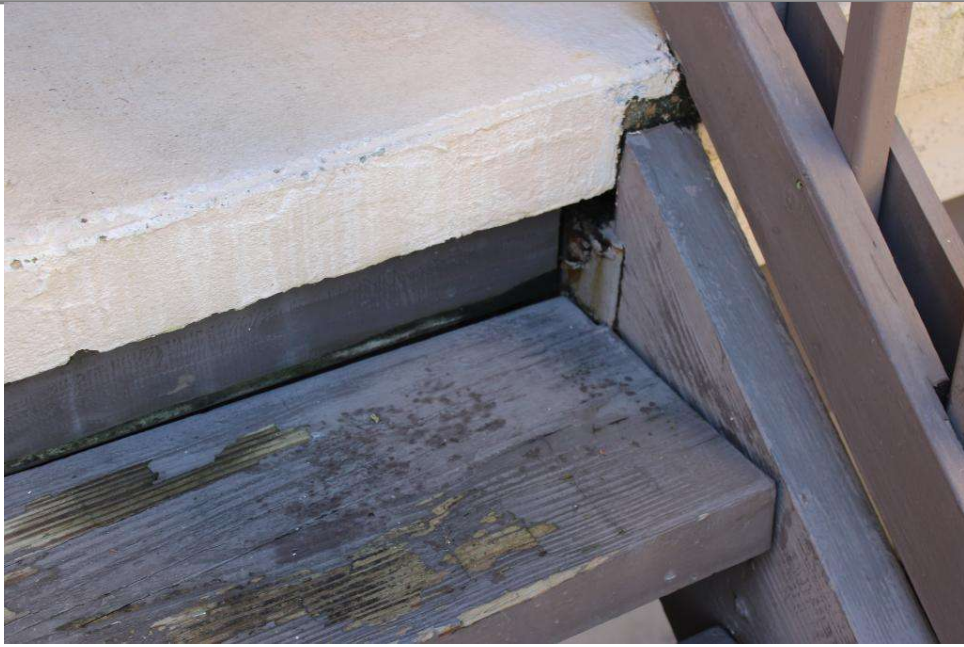
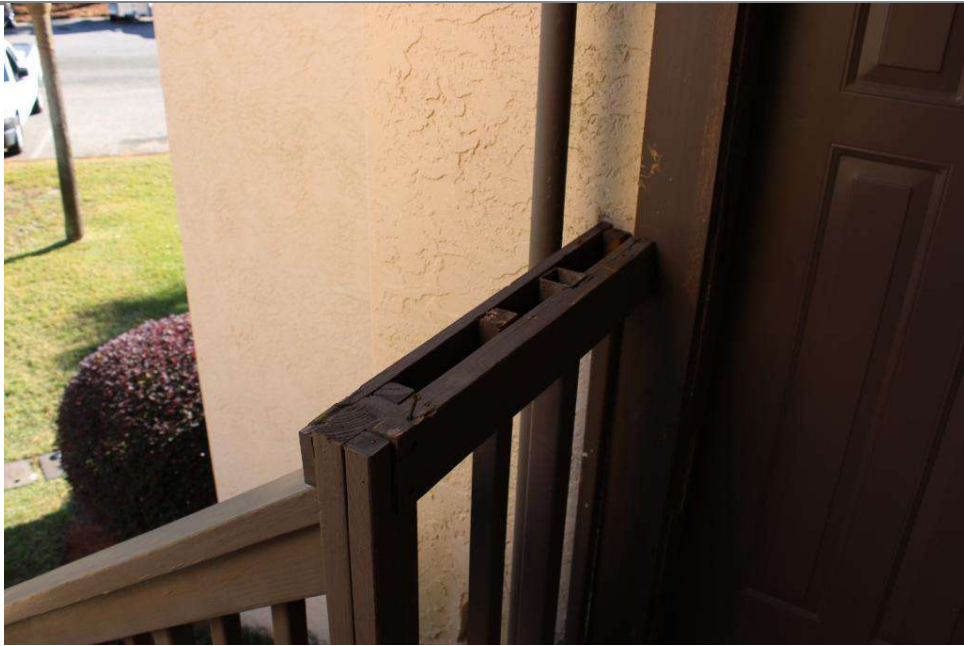
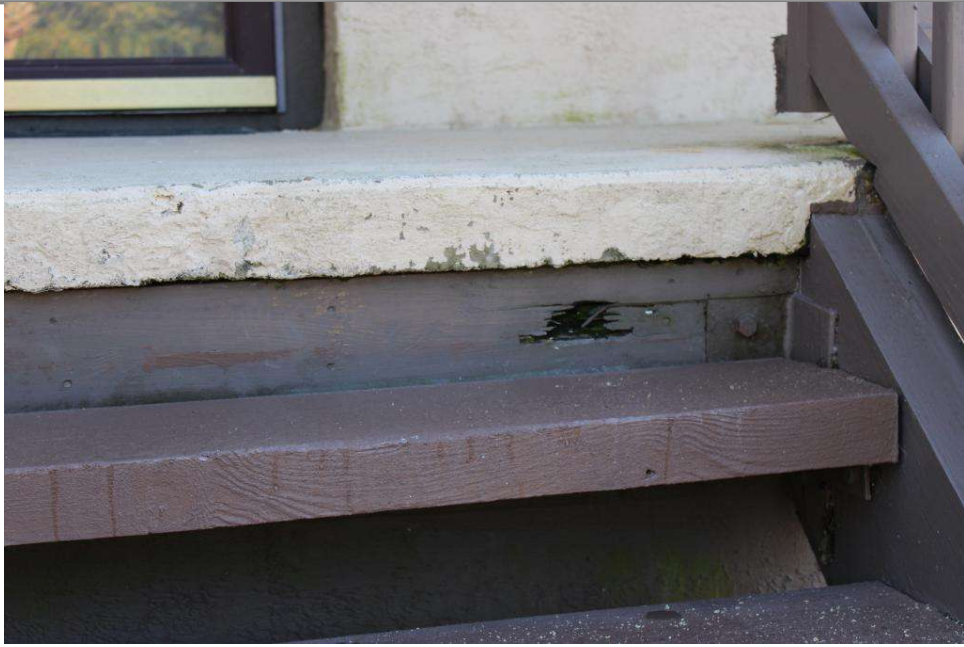
Guardrails Repairs (Front and Back of the Buildings)
