Safe Harbour Village Condominiums

SIRS

Re: Safe Harbour Village Condominiums
 Structural Integrity Reserve Study (SIRS)
 8253 Navarre Pkwy., Navarre, Florida
 UES Project No: 6011.2400258.0000

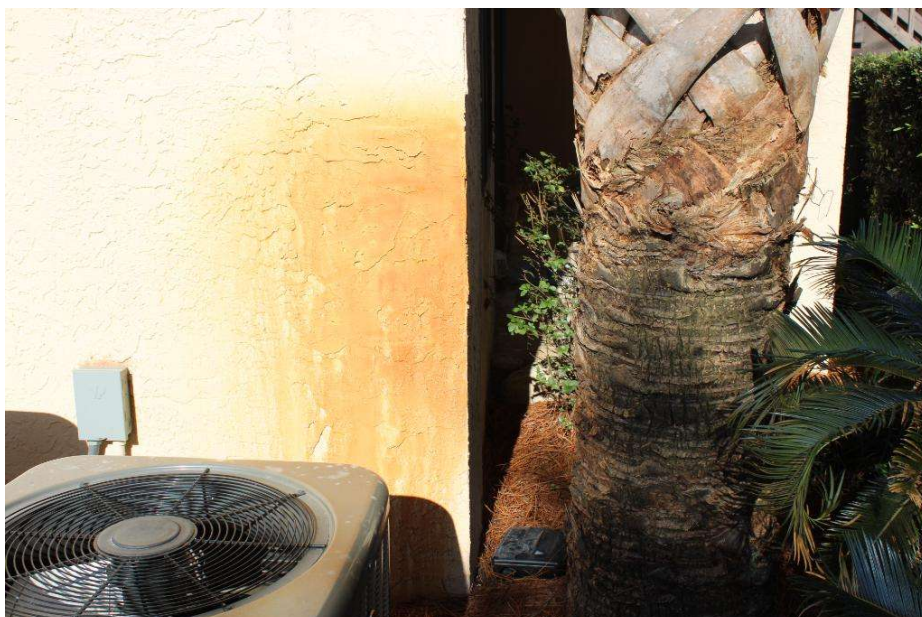
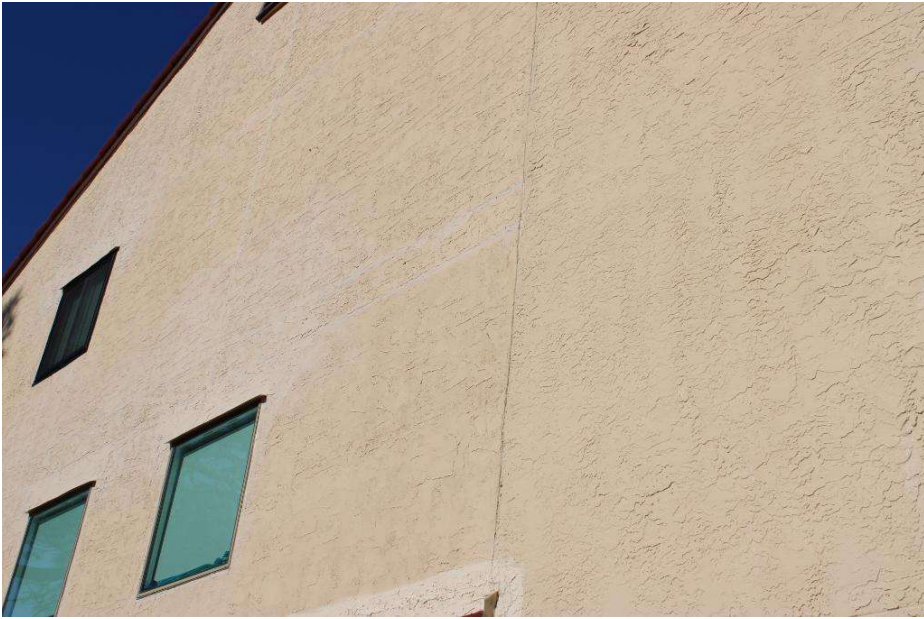
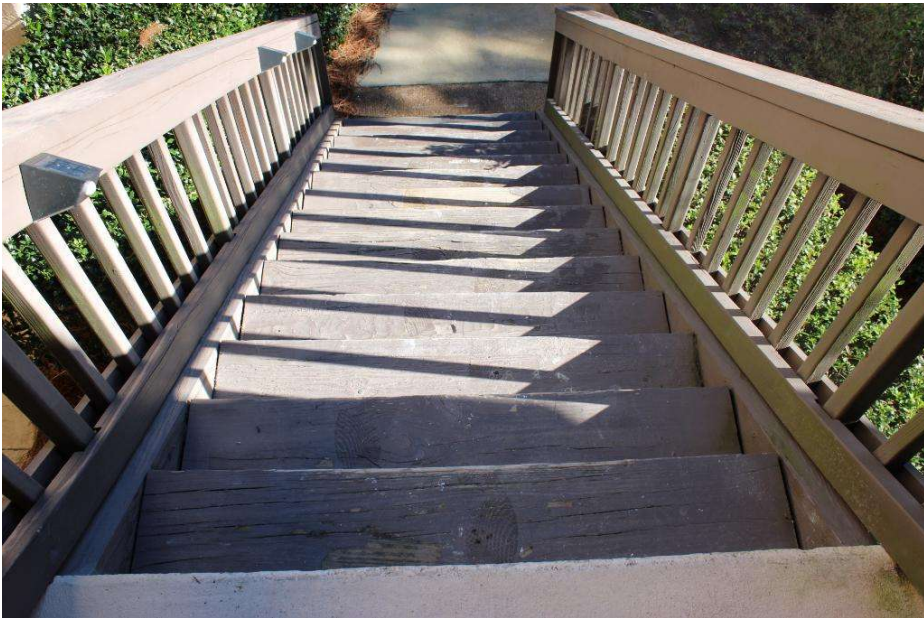
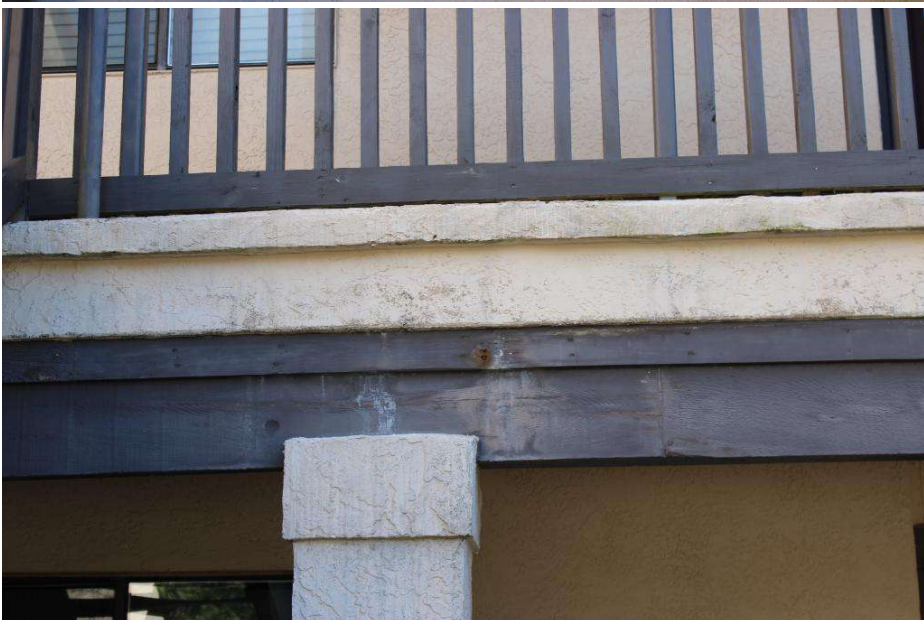
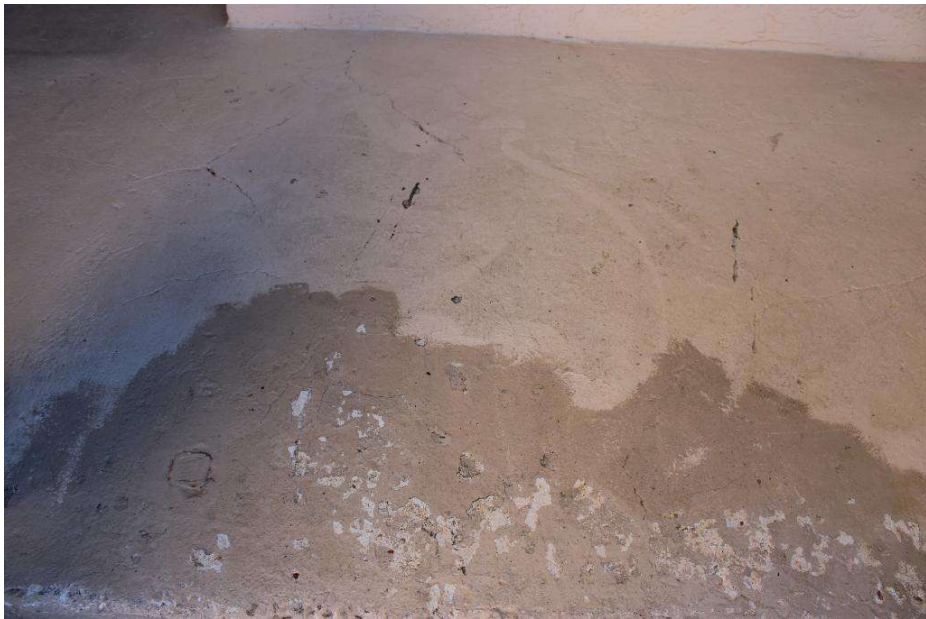
Item	In-Service Date	Next Replacement Date	Quantity	Total Current Cost
Exterior Building paint	01/01/2016	01/01/2026	1 LS	\$94,000.00
Total			1 LS	\$94,000.00

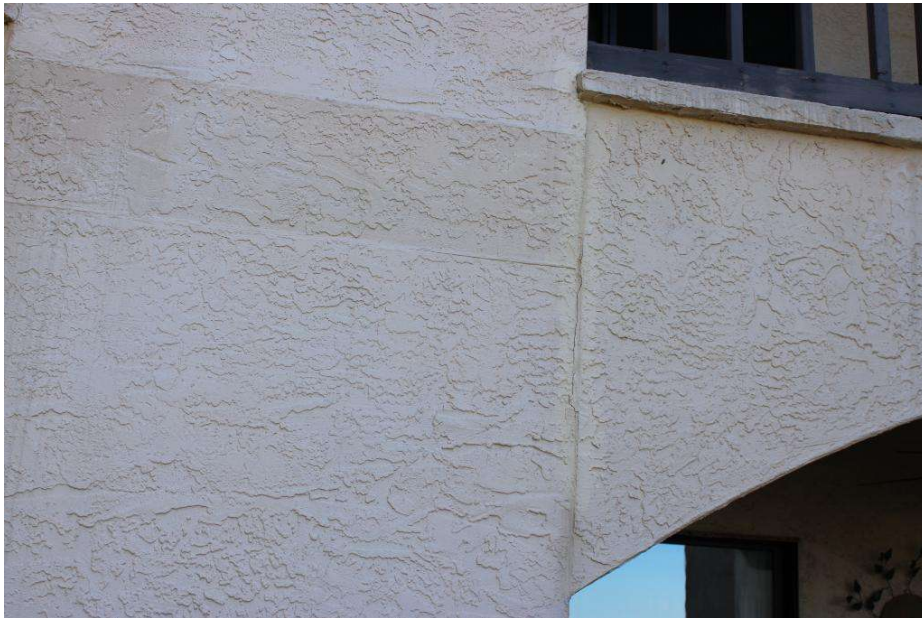
Item	In-Service Date	Next Replacement Date	Quantity	Total Current Cost
Building Sealant	01/01/2016	01/01/2026	1 LS	\$6,000.00
Total			1 LS	\$6,000.00

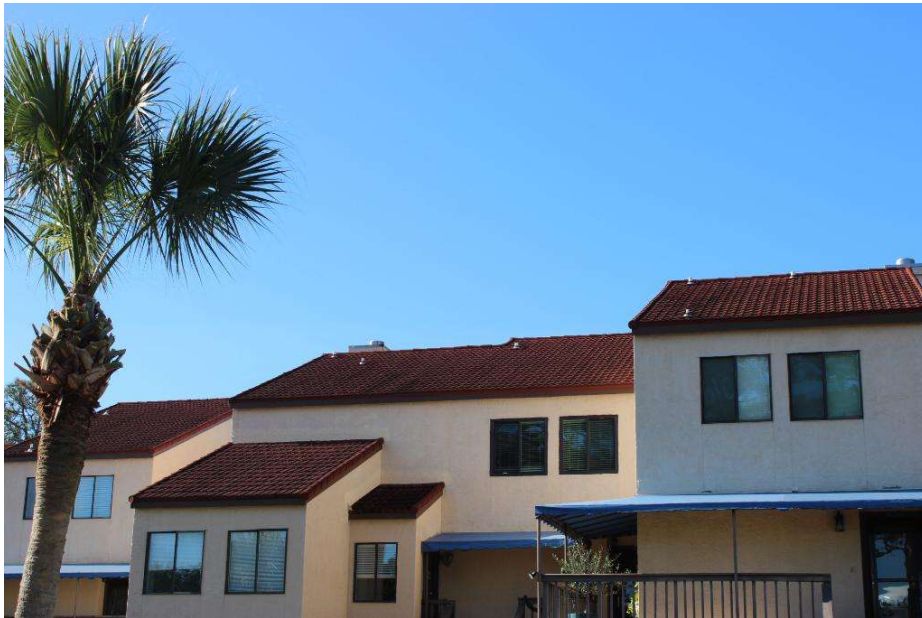
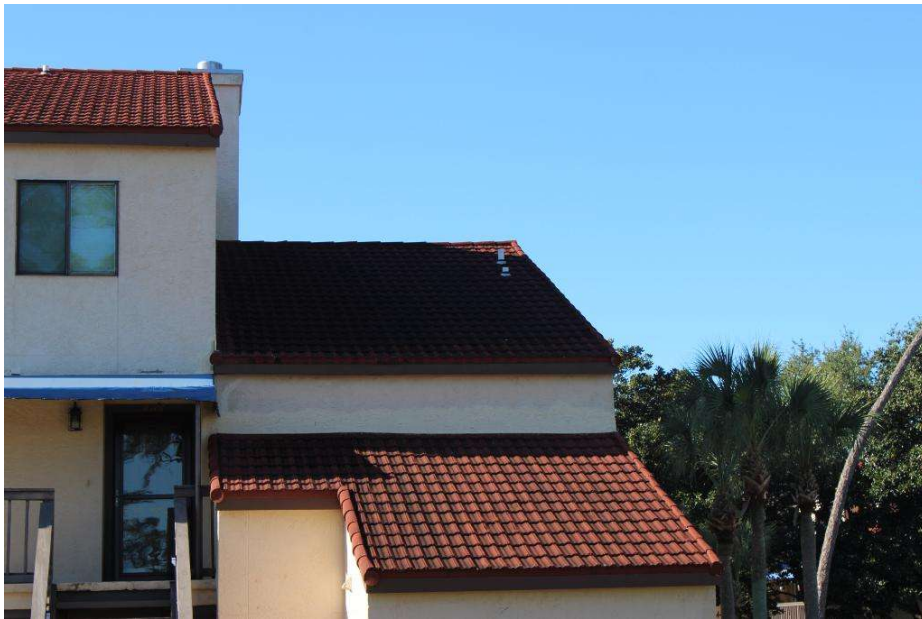
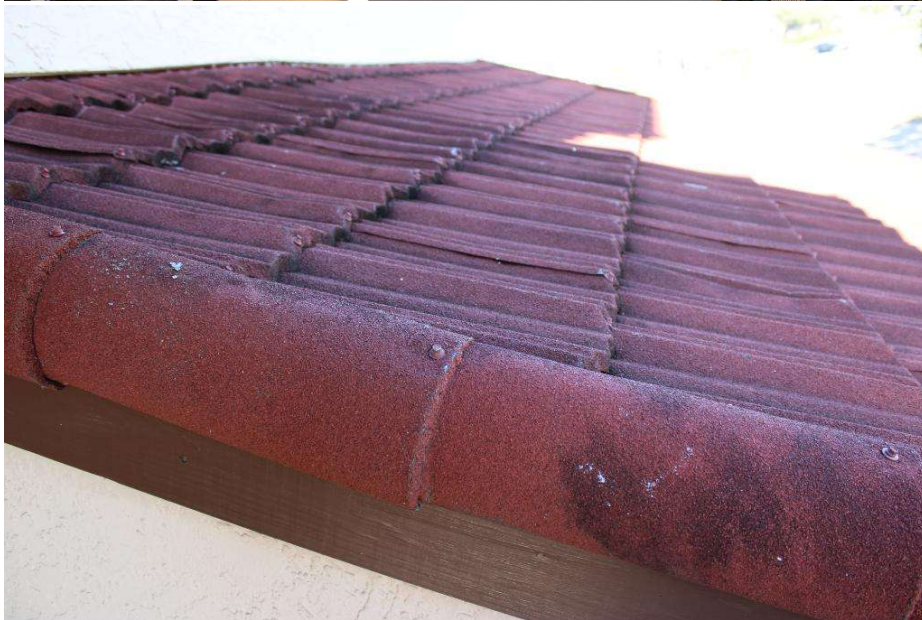
The building has a hipped roof consisting of a pre-engineered wood trusses system covered with metal panels. At the time of inspection the roof was observed to be in good to fair condition.

Item	In-Service Date	Next Replacement Date	Quantity	Total Current Cost
Roof	01/01/2008	01/01/2048	1 LS	\$250,000.00
Total			1 LS	\$250,000.00

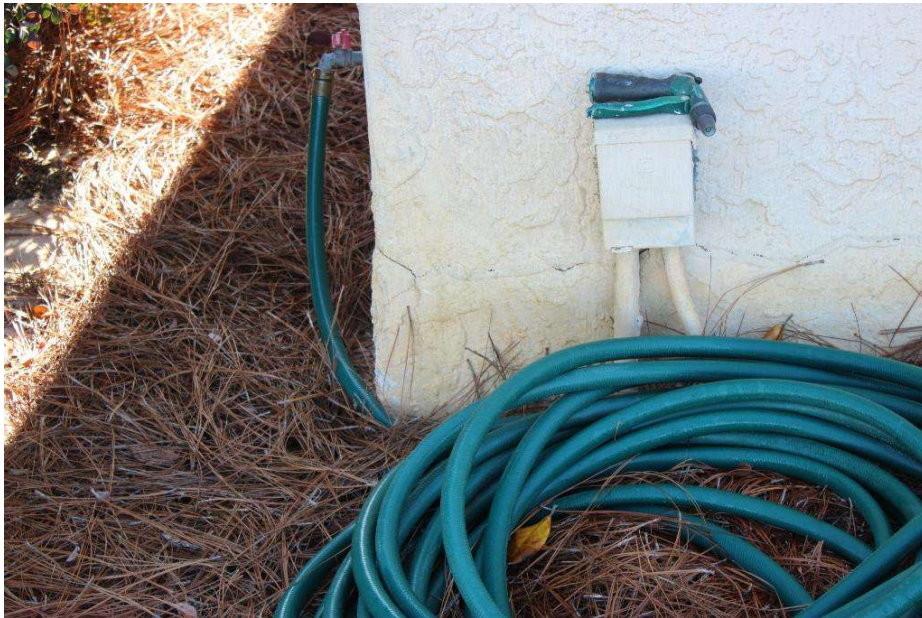
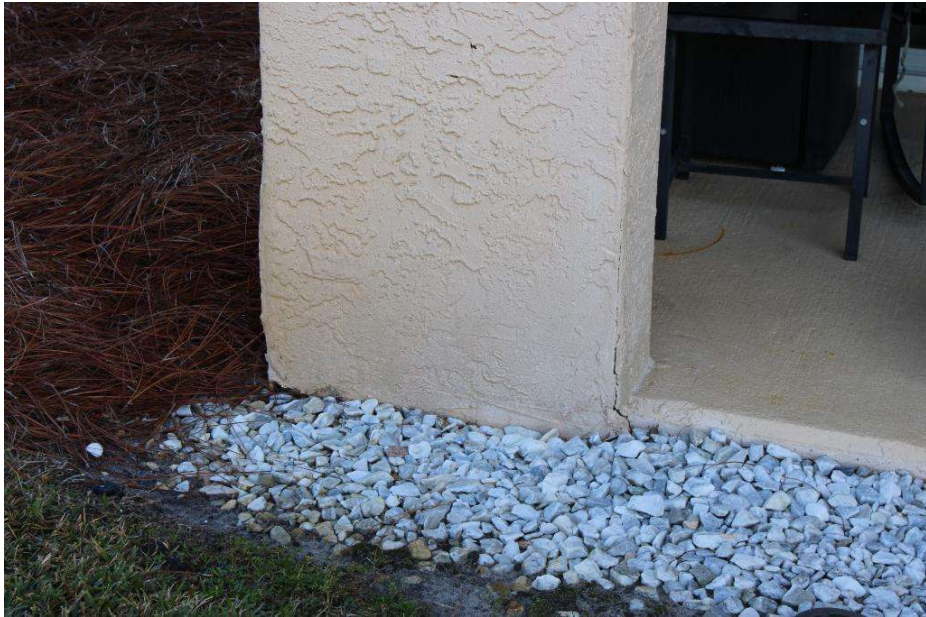
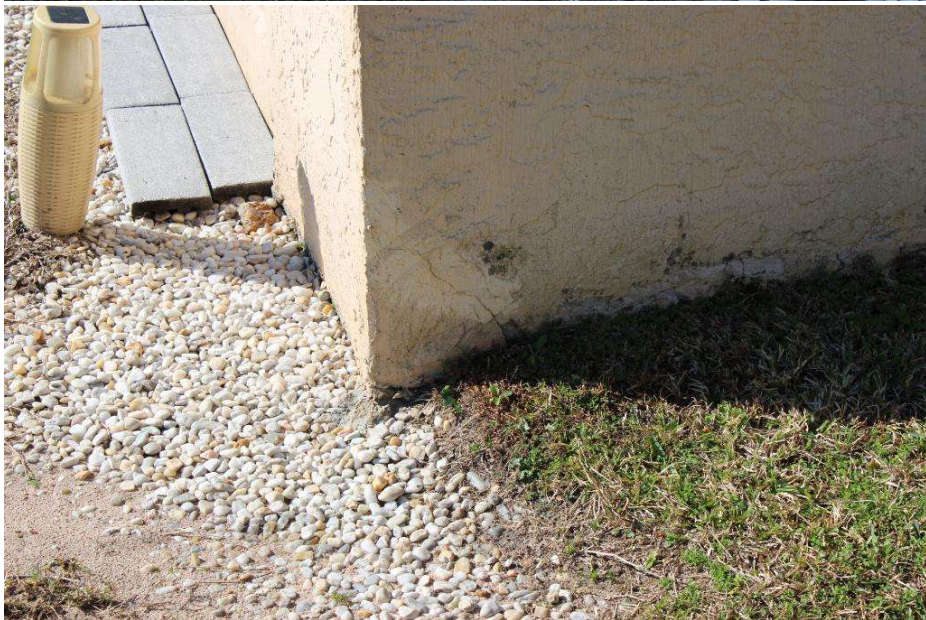
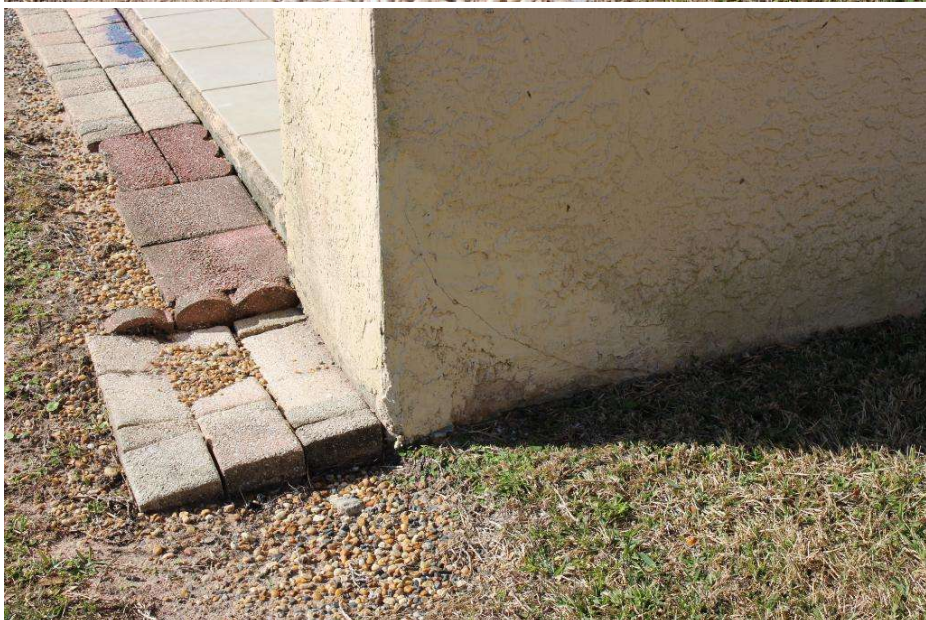
Item	In-Service Date	Next Replacement Date	Quantity	Total Current Cost
Stucco Repair	01/01/2016	01/01/2026	1 LS	\$8,000.00
Total			1 LS	\$8,000.00

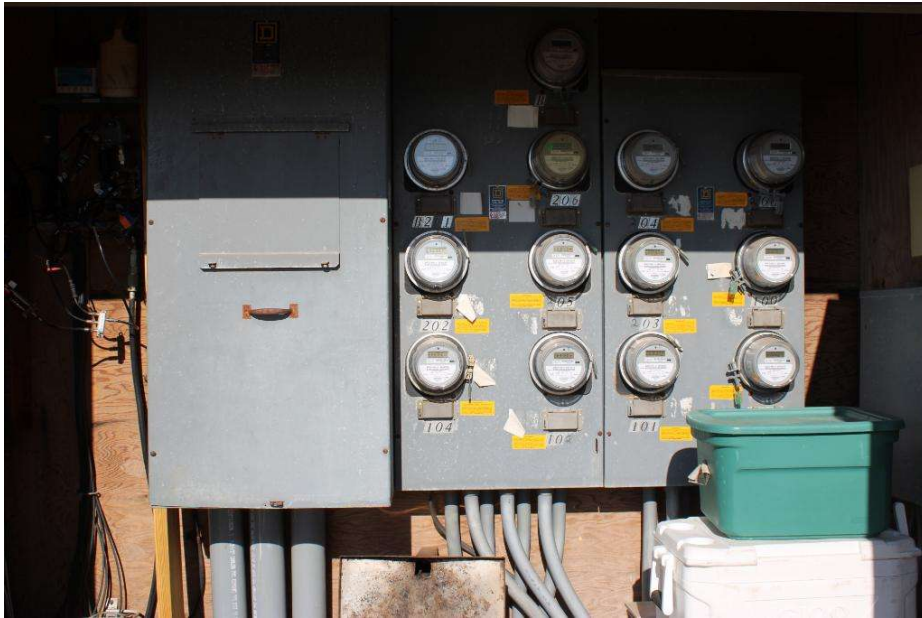
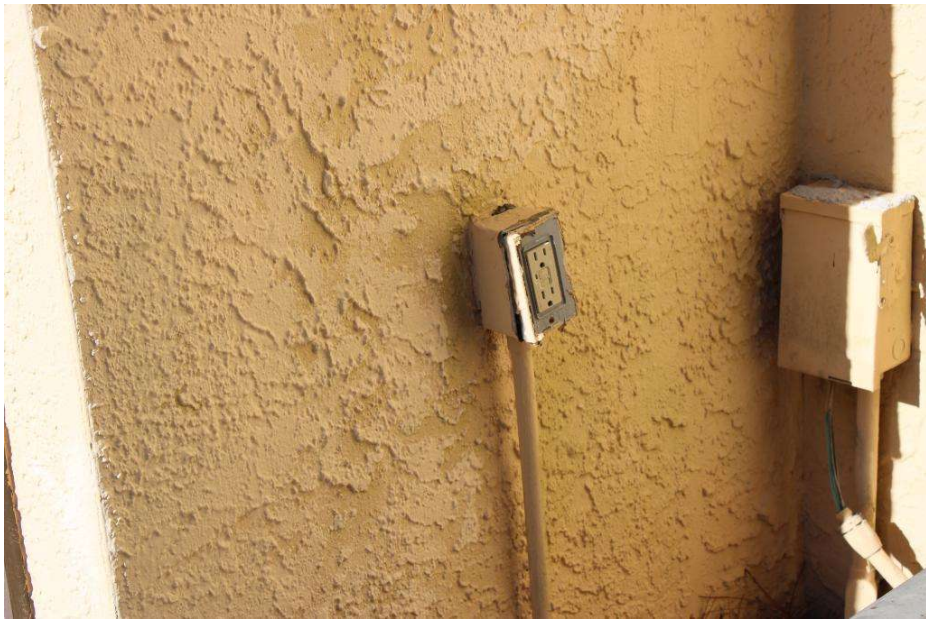
The visible electrical systems inspected at the time of inspection included electrical disconnect, electrical conduits, groundlines and main electrical meters. At the time of inspection, no damage or deficiencies were observed to the electrical systems.

Item	In-Service Date	Next Replacement Date	Quantity	Total Current Cost
Electrical-Annual Routing Maintenance	01/01/2024	01/01/2025	1 LS	\$1,000.00
Total			1 LS	\$1,000.00

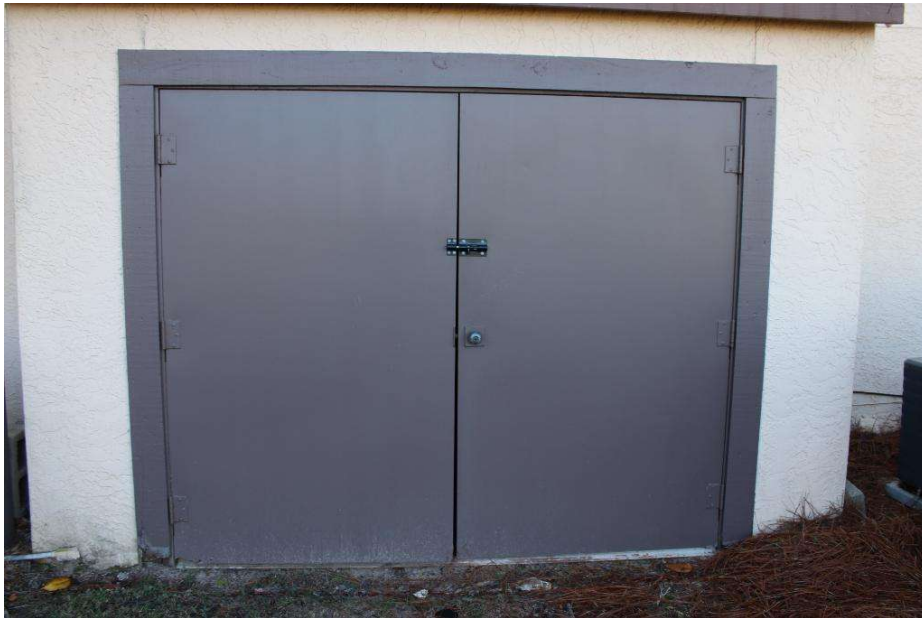
Item	In-Service Date	Next Replacement Date	Quantity	Total Current Cost
Doors	01/01/1983	01/01/2025	2 Ea	\$6,000.00
Total			2 Ea	\$6,000.00

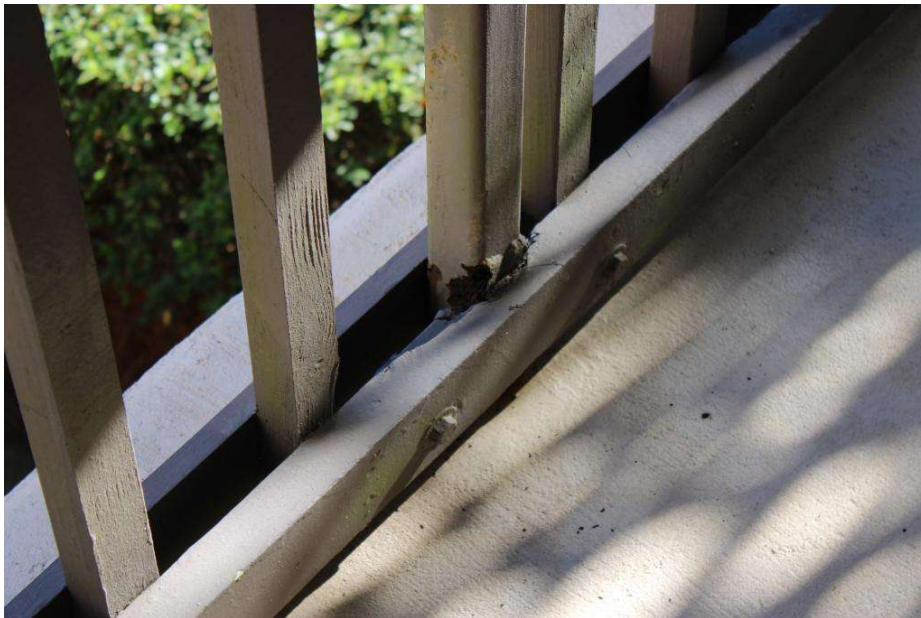
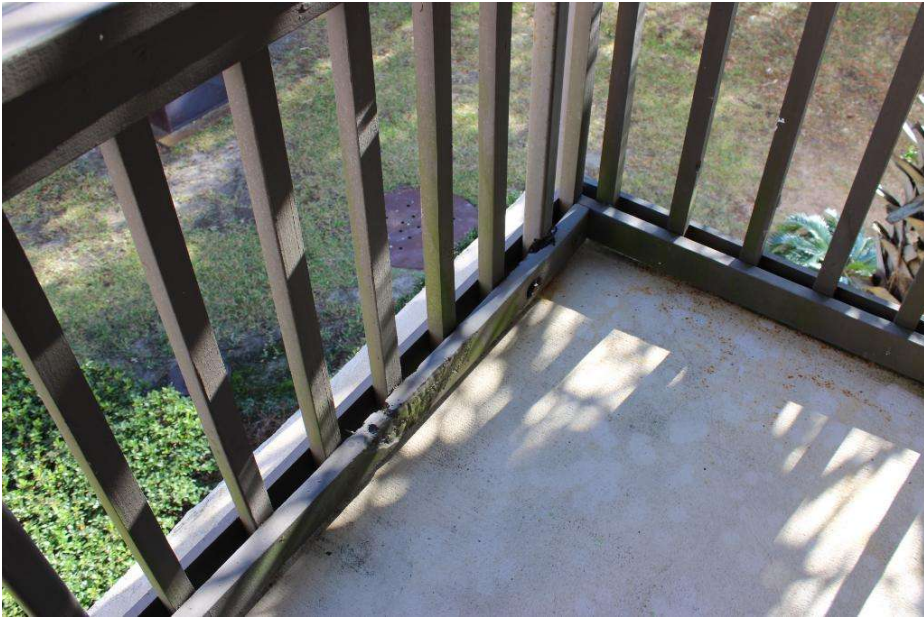
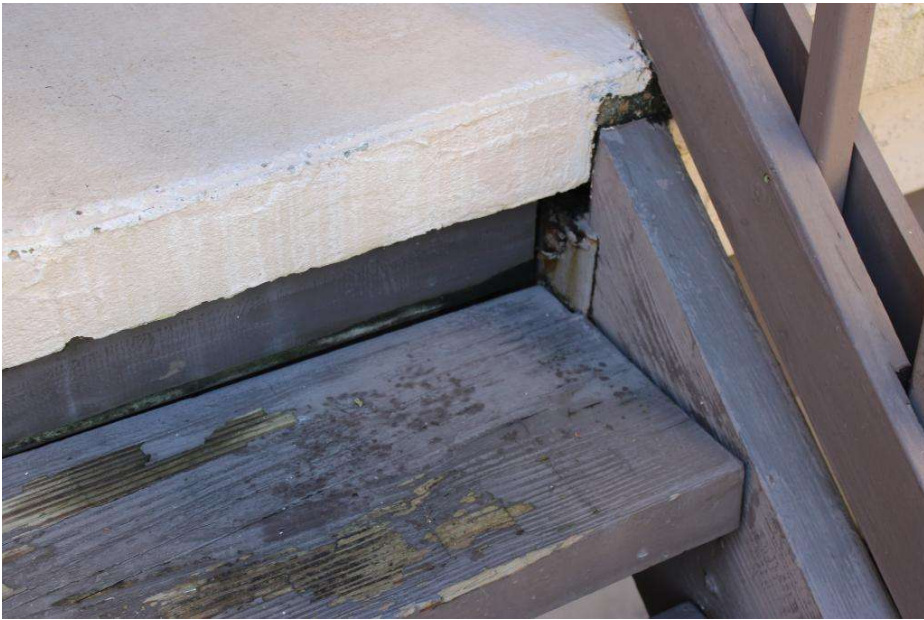
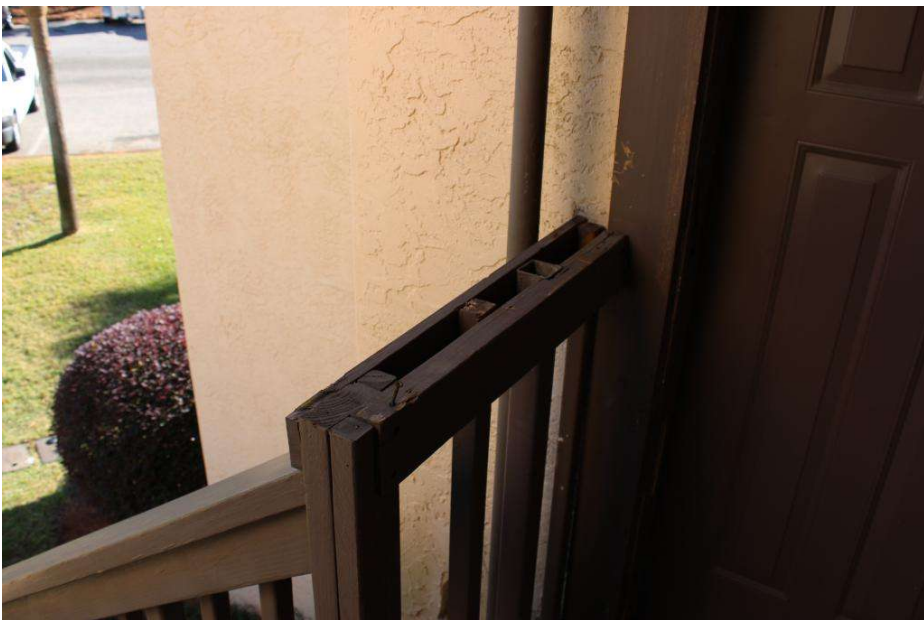
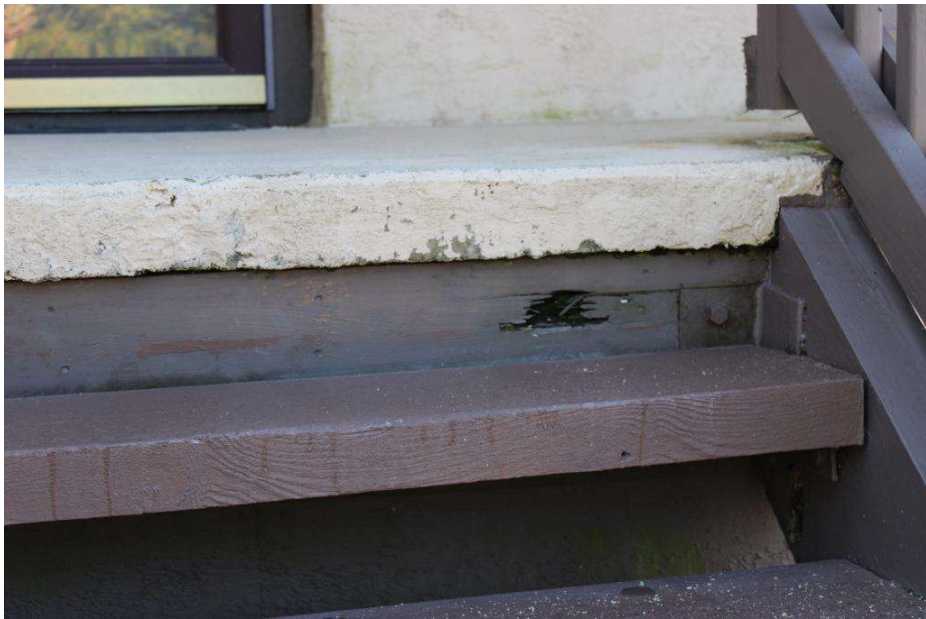
Guardrails Repairs (Front and Back of the Buildings)

Item	In-Service Date	Next Replacement Date	Quantity	Total Current Cost
Guardrails Repairs (Front and Back of the Buildings): Walkways/Stairs	01/01/2025	01/01/2039	0 LS	\$0.00
Total			0 LS	\$0.00
